Controlling Condensation on CWP Insulation

By Ed Light

Building Dynamics, LLC, Ashton, Md.

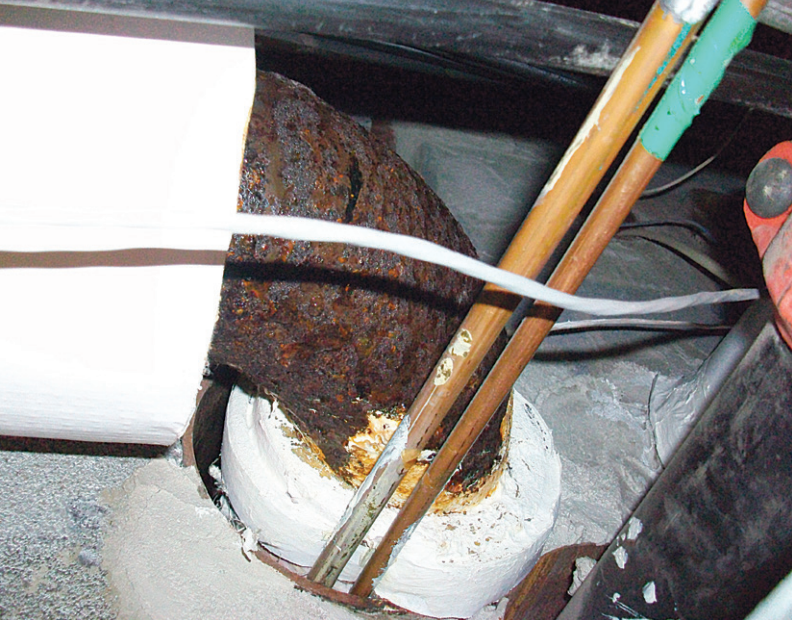
Photo 1: Pipe section left unsealed.

Condensation forms where insulation is missing or insufficient, or vapor barriers are not fully sealed (Photos 1 and 2). Condensation wets the insulation and this moisture can wick through fibrous

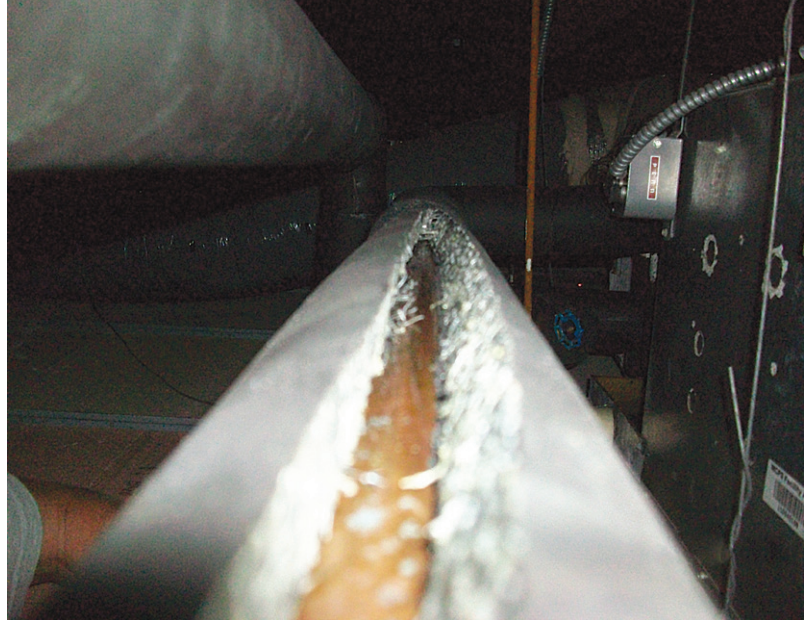
Photo 2: Insulator failed to seal top seam.

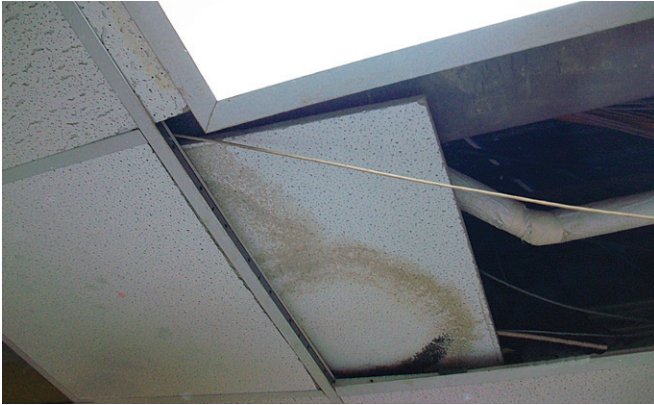
Photo 3: Stained ceiling tile under sweating chilled water pipe.

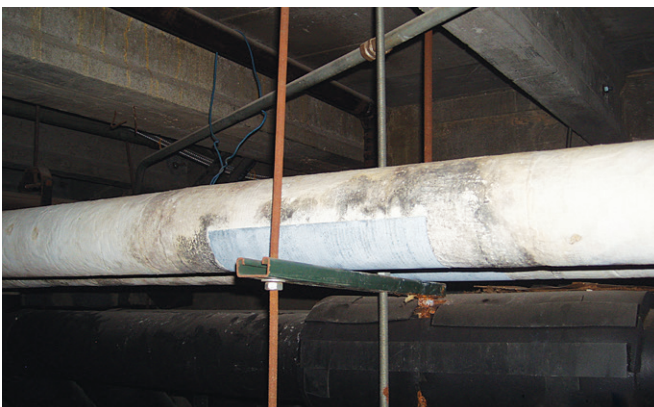
The condition of CWP insulation with respect to condensation control can be assessed visually, by identifying insulation deficiencies and noting the relative severity and extent of water damage. Examples of staining patterns considered minor and major are illustrated in Photos 4 and 5. Suspect growth is often present in areas with major condensation. Where suspect spotting is not associated with water stains on the insulation, the root cause

Photo 4: Major water damage.

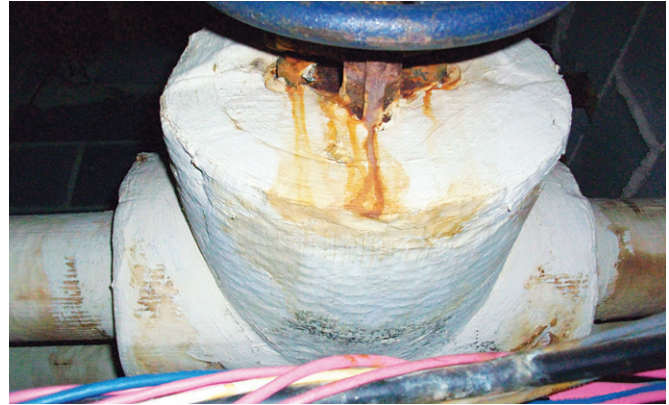
Photo 5: Minor water damage.

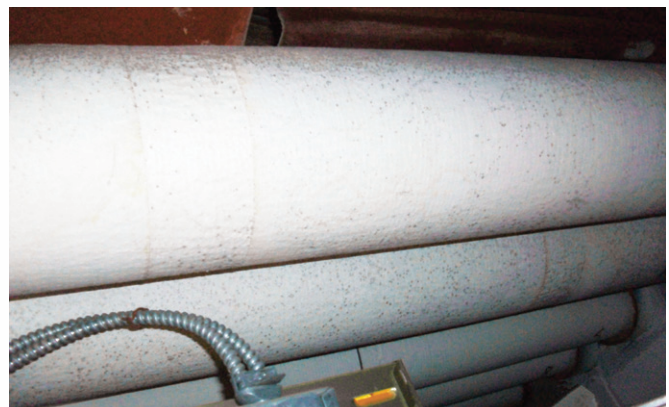
may be excessive space humidity, not insulating deficiencies (Photo 6).

Photo 6: Mold spotting caused by excessive humidity.

In some areas, the underlying cause of suspect spotting on CWP insulation is not defective workmanship, but excessive space humidity. Improved humidity control is needed to protect CWP insulation in these areas.

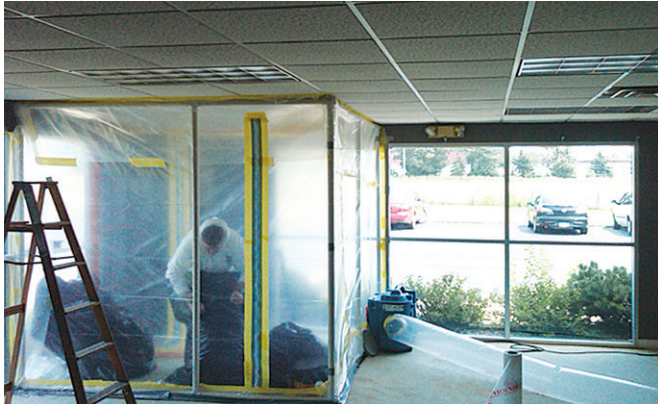
Photo 7: Insulation removal following hazardous material procedure.

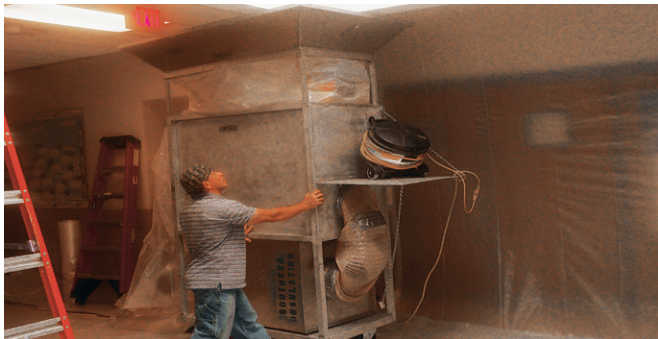
ventilation. Insulation is removed over a portable hood and underlying surfaces are covered with plastic sheeting. The ventilation unit consists of an inverted exhaust hood atop an aluminum portable rolling containment, with a HEPA-filtered exhaust system. Height of the hood is adjustable and it is set just below the piping (Photo 8).

Photo 8: Insulation removal using portable hood.

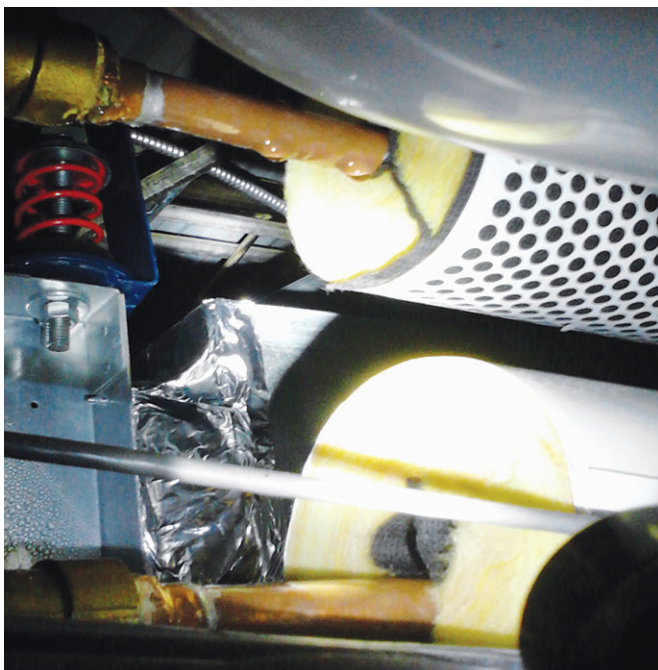
In contrast, major condensation associated with vapor barrier defects was observed from insulation installed without enhanced QC measures (Photo 9).

Photo 9: Incomplete insulation installed without enhanced quality control.
