HVAC in Corrosive Environment

By **Mahesh R. Mehta** Ecochem Plus, Mumbai

Part 5

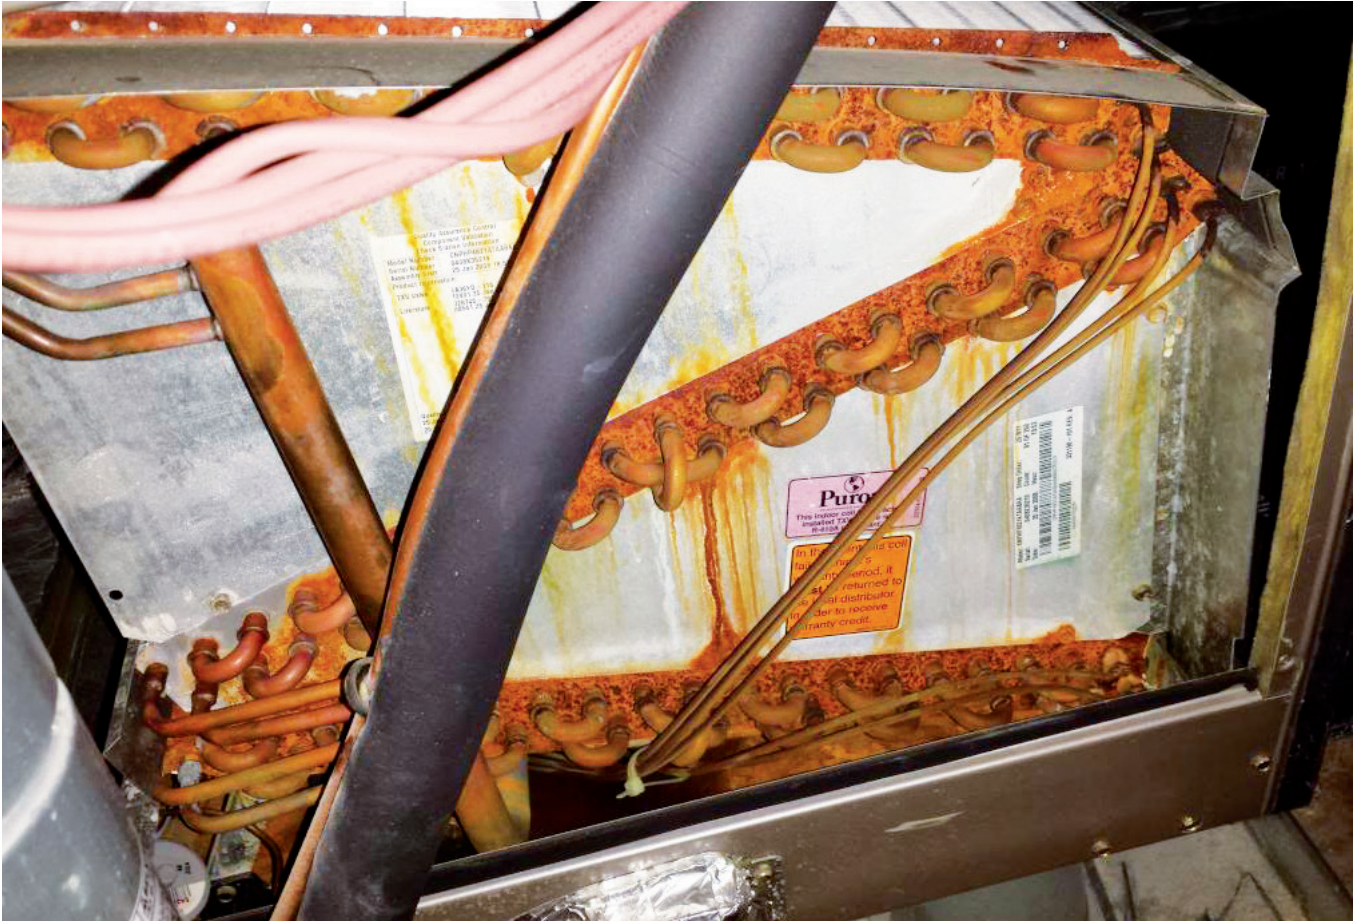
Formicary corrosion in a coil

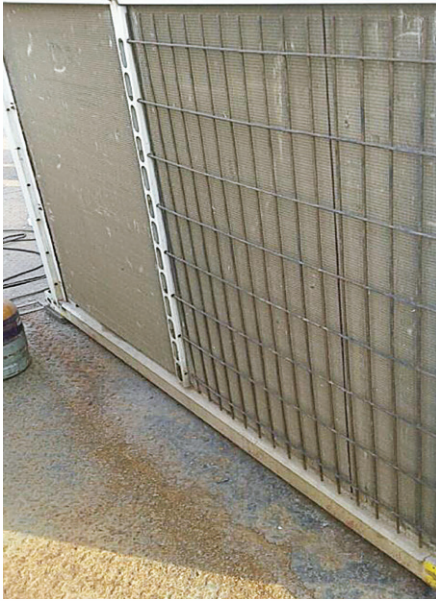
Photo 1: A dirty coil before the coating process

Figure 1 and 2 show the condition of the coil and fins: extremely dirty and fins oxidized to a large extent. We started with deep coil cleaning with suitable cleaning chemicals of various materials, as well as degreasers to remove oil traces. Chemicals were eco-friendly, which acted only on contamination but were safe for the metal.

Deep coil cleaning process was a combination of mechanical and chemical cleaning. After a few days of hard work, the coil was free of contamination. Cleaning is the dirtiest part of the job, as readers might have noticed while getting their house painted. It takes a few days to remove old paint, plastering and surface preparation. This preparatory process lays the foundation for success, and takes 80-85% of the time. There is no short cut here.

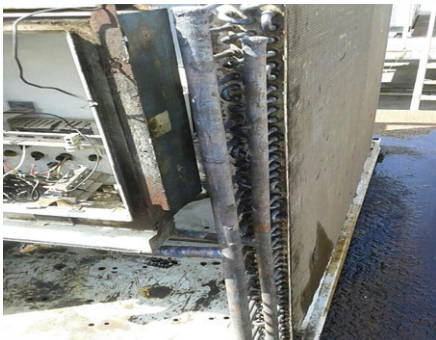
Photo 3: Contaminated coil and header

Photo 3 shows the condition of the coil contaminated with oil and the header.

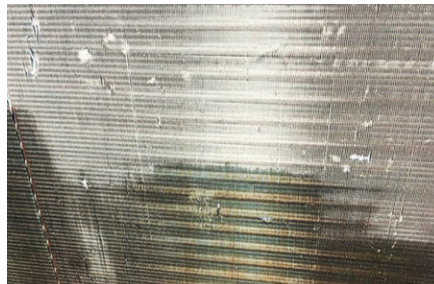
Photo 6: Restored coil area after deep cleaning and nano coating of fins (please note easy visibility of deep rows)

Once the coil was fully dried up, we did the final coating as shown in Photo 4 to 6.
