HVAC in Corrosive Environment

By Mahesh R. Mehta Ecochem Plus, Mumbai

Part 2

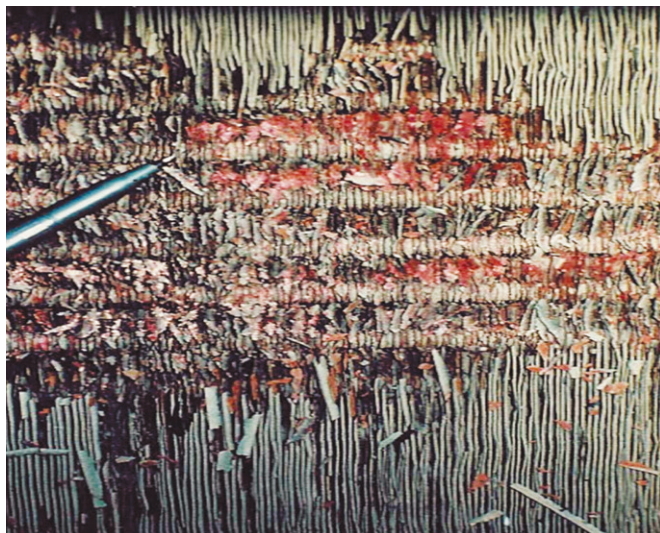
Figure 9: Copper coil exposed to salt air and burning of sugar fields, located 2 km from sea shore, for 18 months showing loss of fins and built-up oxides

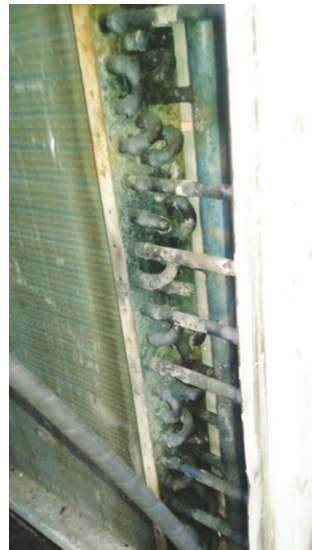
Figure 11: Old header with paint and rust oxides

In a recent assignment, the author has revived an old unit on the verge of being junked, by repairing the header and U-bend, deep coil cleaning and fin coating. (Note increase in fin sharpness in the final photo). Old copper tubes with multiple coating were also chemically cleaned and re-coated.

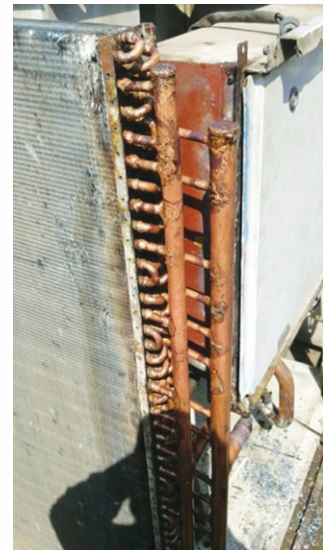
Figure 12: Chemically cleaned and coated header

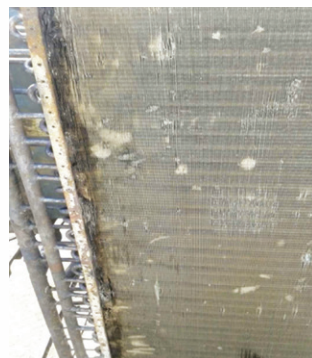
Figure 13: Old coil with dirt and corrosion

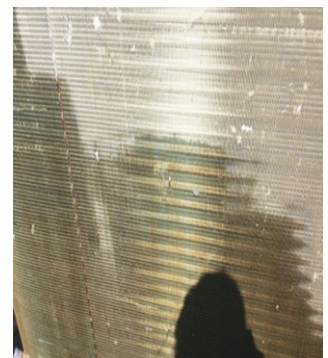
Figure 14: Restored coil after fin cleaning and nano coating
