Revamping Old AHUs to Provide a Clean & Healthy Environment

By R. Gopalakrishnan

Scientific Officer,
Indira Gandhi Centre for Atomic Research (Reprocessing Group)
Kalpakkam, Tamil Nadu

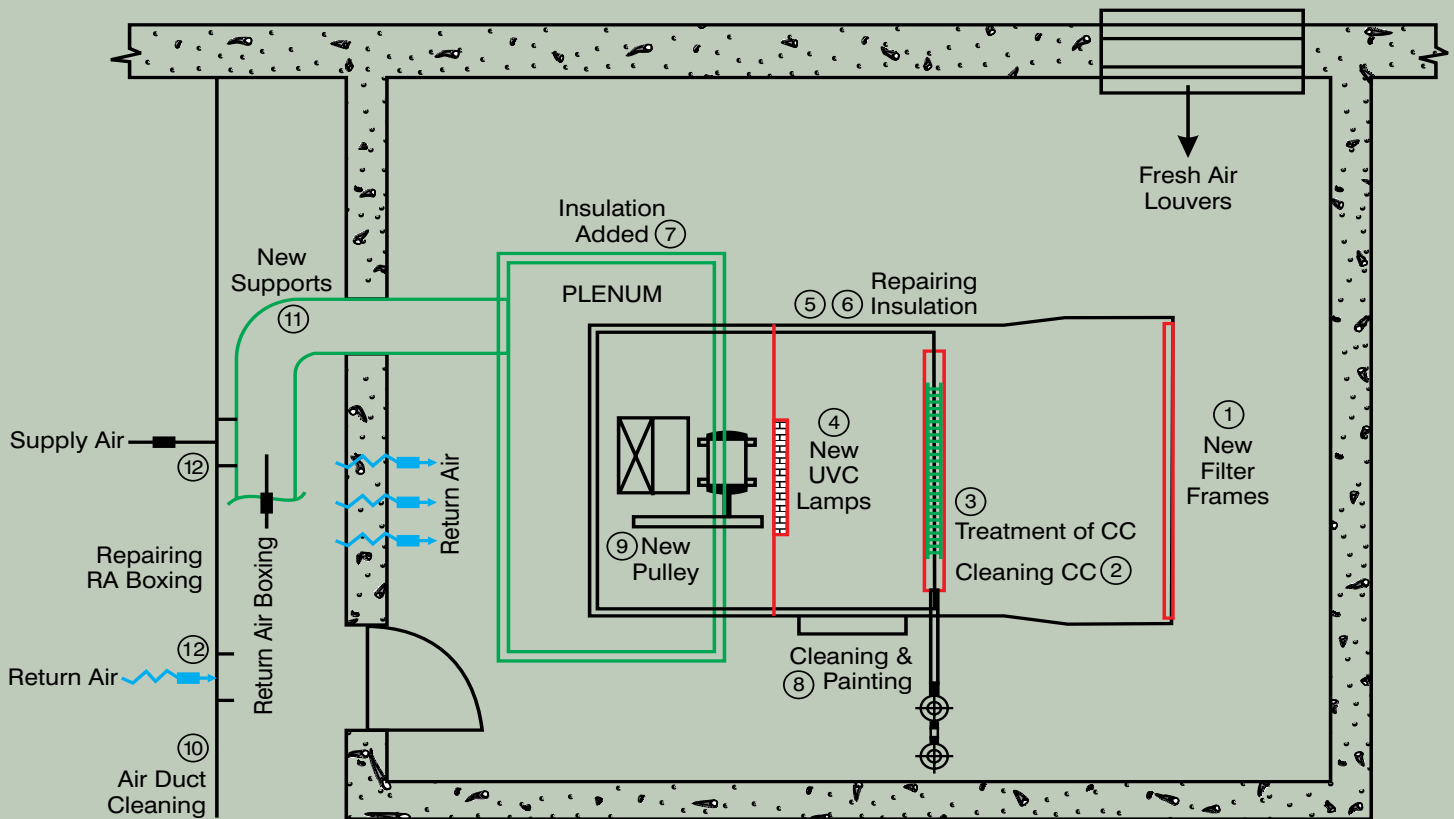
Schematic layout of AHU room showing details of work carried out. (numbers connect to items in article)

List of Works Carried Out Are:

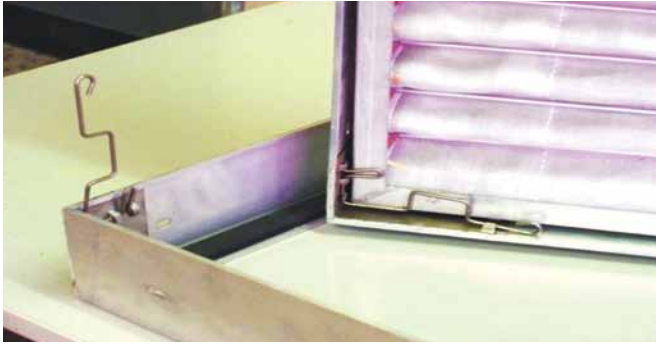
Figure 1: View of the Universal Holding Filter Frame (UHFF) – holding clamp in open position on left; UHF with filter and holding clamp in locked position on right.

Existing conventional sliding type filter frames were replaced with new high performance aluminium extruded Universal Holding Filter Frame (UHFF) as a retro fitment. See Figure 1 & 2.

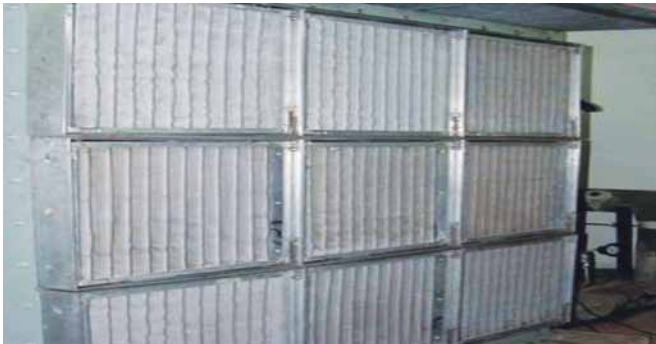
Figure 2: View of retro fitted new high performance aluminium extruded Universal Holding Filter Frames (UHFF).

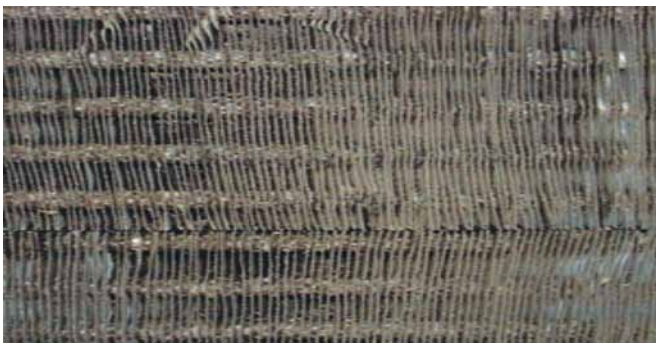
Figure 3: View of the AHU cooling coil before cleaning.

2. Cleaning of Cooling Coils. Cooling & dehumidification coils cleaned with environment-friendly bioactive enzymes instead of acid. See Figure 3 & 4.

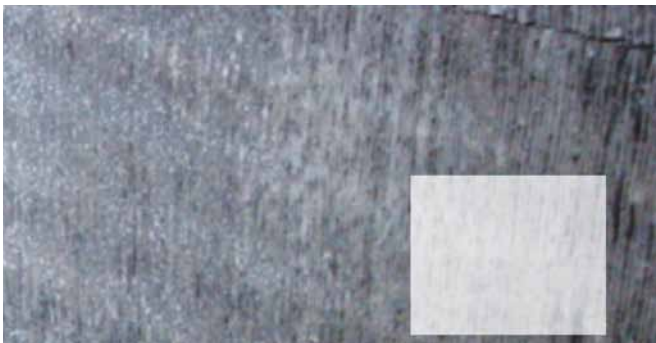
Figure 4: View of the AHU cooling coil after cleaning.

3. Treatment of Cooling Coils. Cooling coils treated with environment-friendly bioactive enzymes to retard the growth of mold again over the coil.

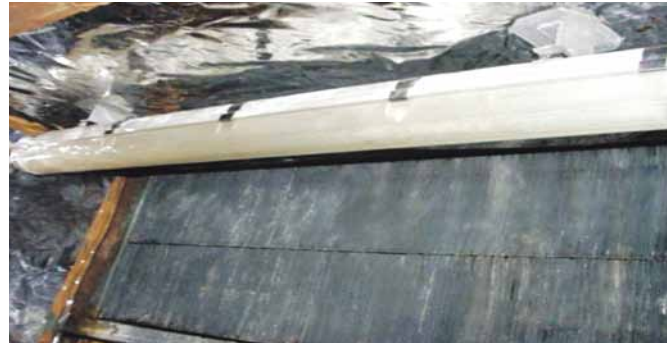
Figure 5: View of UVC (Ultra Violet C Band) germicidal lamp, fitted inside the AHU-5

4. New UVC (Ultra Violet C band) Germicidal Lamps Fitted. Ultra Violet C band (UVC) lamps were introduced in order to improve industrial hygiene. Providing the UVC lamps, in AHUs of HVAC systems are a mandatory requirement in USA as per Facilities Standard 2003 (P100) of Public Building Service of GSA Section 5.9 "HVAC Systems". Ultra Violet C band germicidal lamps retard growth of bio aerosols. See Figure 5 & 6.

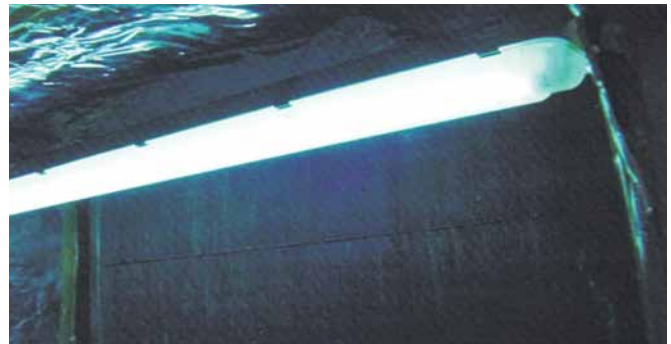
Figure 6: View of UVC (Ultra Violet C Band) germicidal lamp, fitted inside the AHU-5, while glowing.

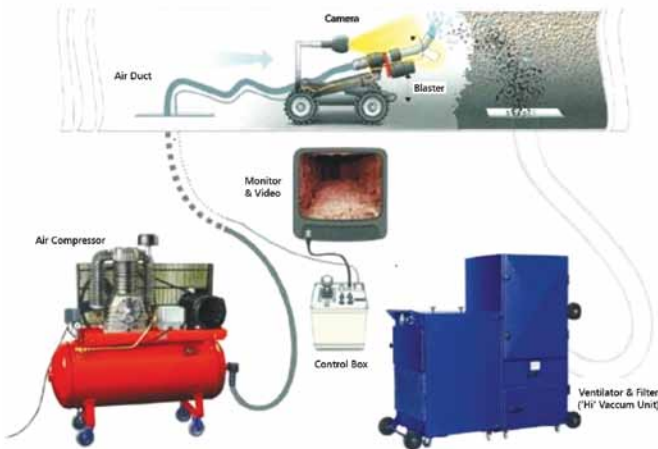
Figure 7: Illustration of duct cleaning method. Compressed air is supplied at positive pressure through duct cleaning tools to dislodge the accumulated dust in the ducting and at negative pressure, high vacuum, a HEPA filter unit is connected through suction flexible duct to collect and hold the dust.

10. Air Duct Cleaning as per National Air Duct Cleaners Association (NADCA) ACR 2006 Standard-Assessment, Cleaning and Restoration of HVAC Systems – Procedure and Specification. Entire air ductwork was cleaned in order to remove all the accumulated dust in the ducting by using remotely handled robotic camera and cleaning tools by source removal concept.

See Figures 7 & 8.

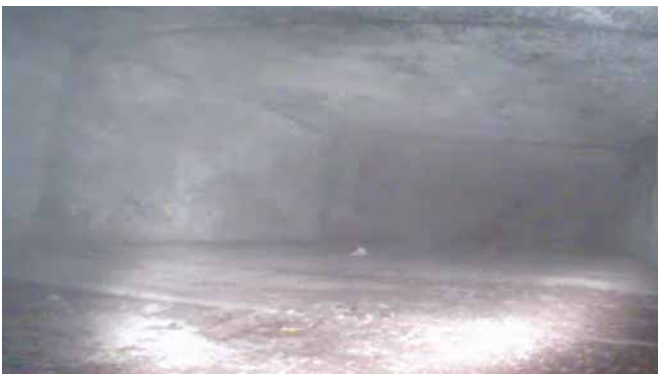
Figure 8: Robotic camera image after duct cleaning process.
