HVAC in Corrosive Environment

By Mahesh R. Mehta Ecochem Plus, Mumbai

Part 3

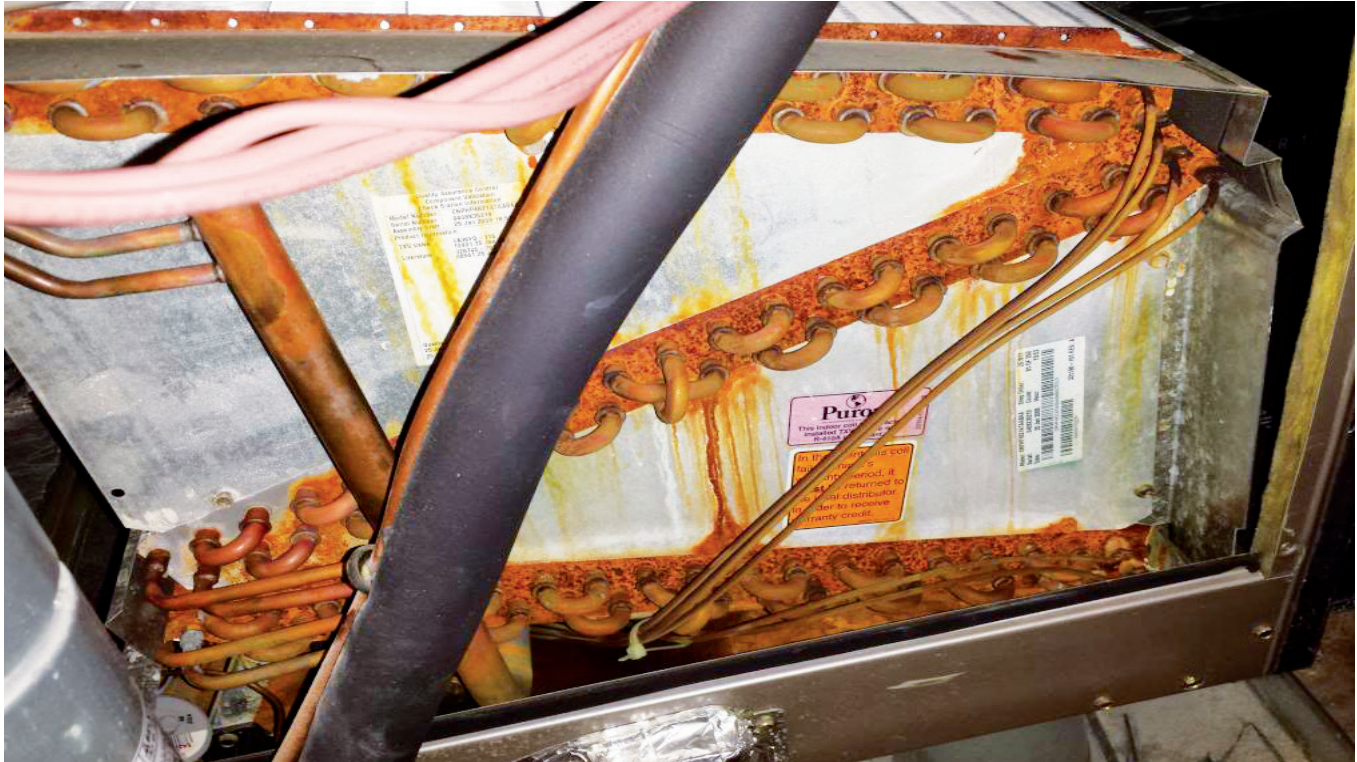
Formicary corrosion in a coil

In a coastal salt laden environment, aluminium fins deteriorate in the first 30 days. Grayish salt deposits on the surface of fin stock. This indicates that oxidation process has started – this is the beginning of fin embrittlement. As this process continues, heat transfer capacity of fin stock reduces, thereby increasing operating costs. Up to 55% loss of efficiency can be noted in the first two years, resulting in compressor over-working, tripping and ultimate failure. In an example quoted in Part 1 of this article, fins had swollen up with no loss of strength but a severe reduction in heat transfer. This resulted in compressor tripping and failure.

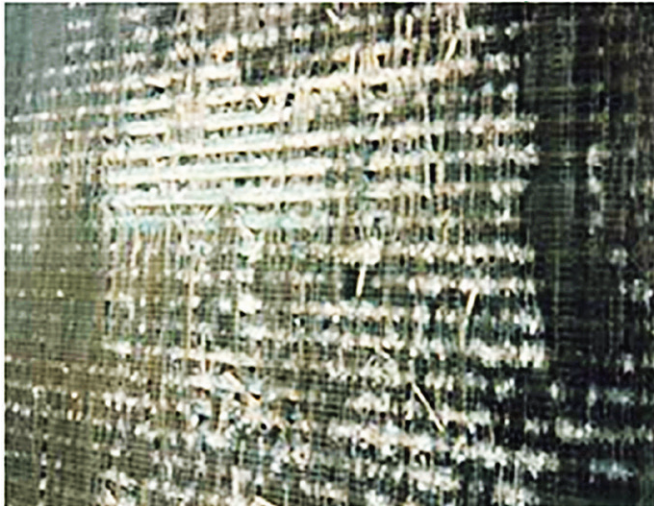
Untreated coil in saline environment

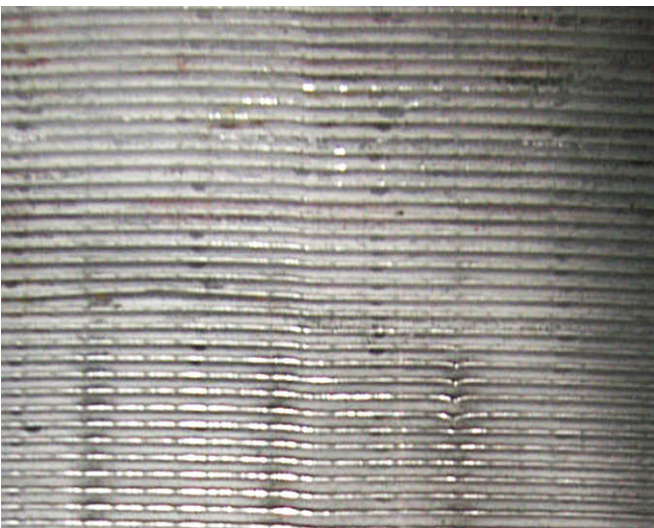
Professional treated coil in same environment
